# **Mobile Intel® Celeron® Processor at 466 MHz, 433 MHz, 400 MHz, 366 MHz, 333 MHz, 300 MHz, and 266 MHz Specification Update**

Release Date: April 2002

Order Number: 244444-031

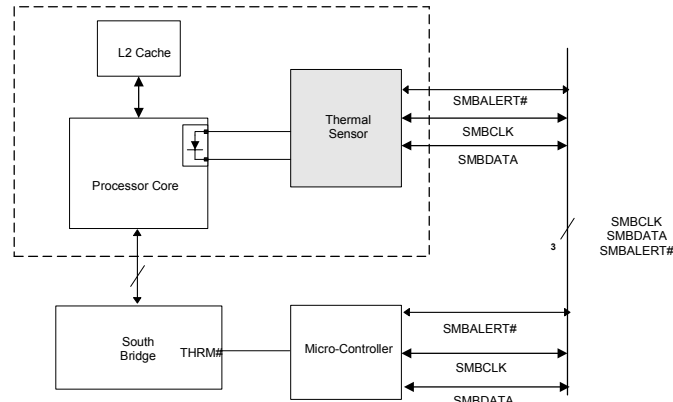
**Problem:** The Intel Celeron Processor Mobile Module has a thermal sensor that monitors the processor core's temperature. Please note that desktop systems could have a similar thermal device. The thermal sensor asserts SMBALERT# if the processor temperature exceeds the temperature limits set in the Alarm Threshold Registers ( $T_{HIGH}$ ,  $T_{LOW}$ ). It also sets the corresponding Status Register bits to identify the cause of the interrupt. Figure 1 gives one example of the how the SMBALERT# signal could be used in a system.

**Figure 1. An Example of Microcontroller Driven Thermal Management**
